Drawn by Richard Hassebrock
8/26/2010

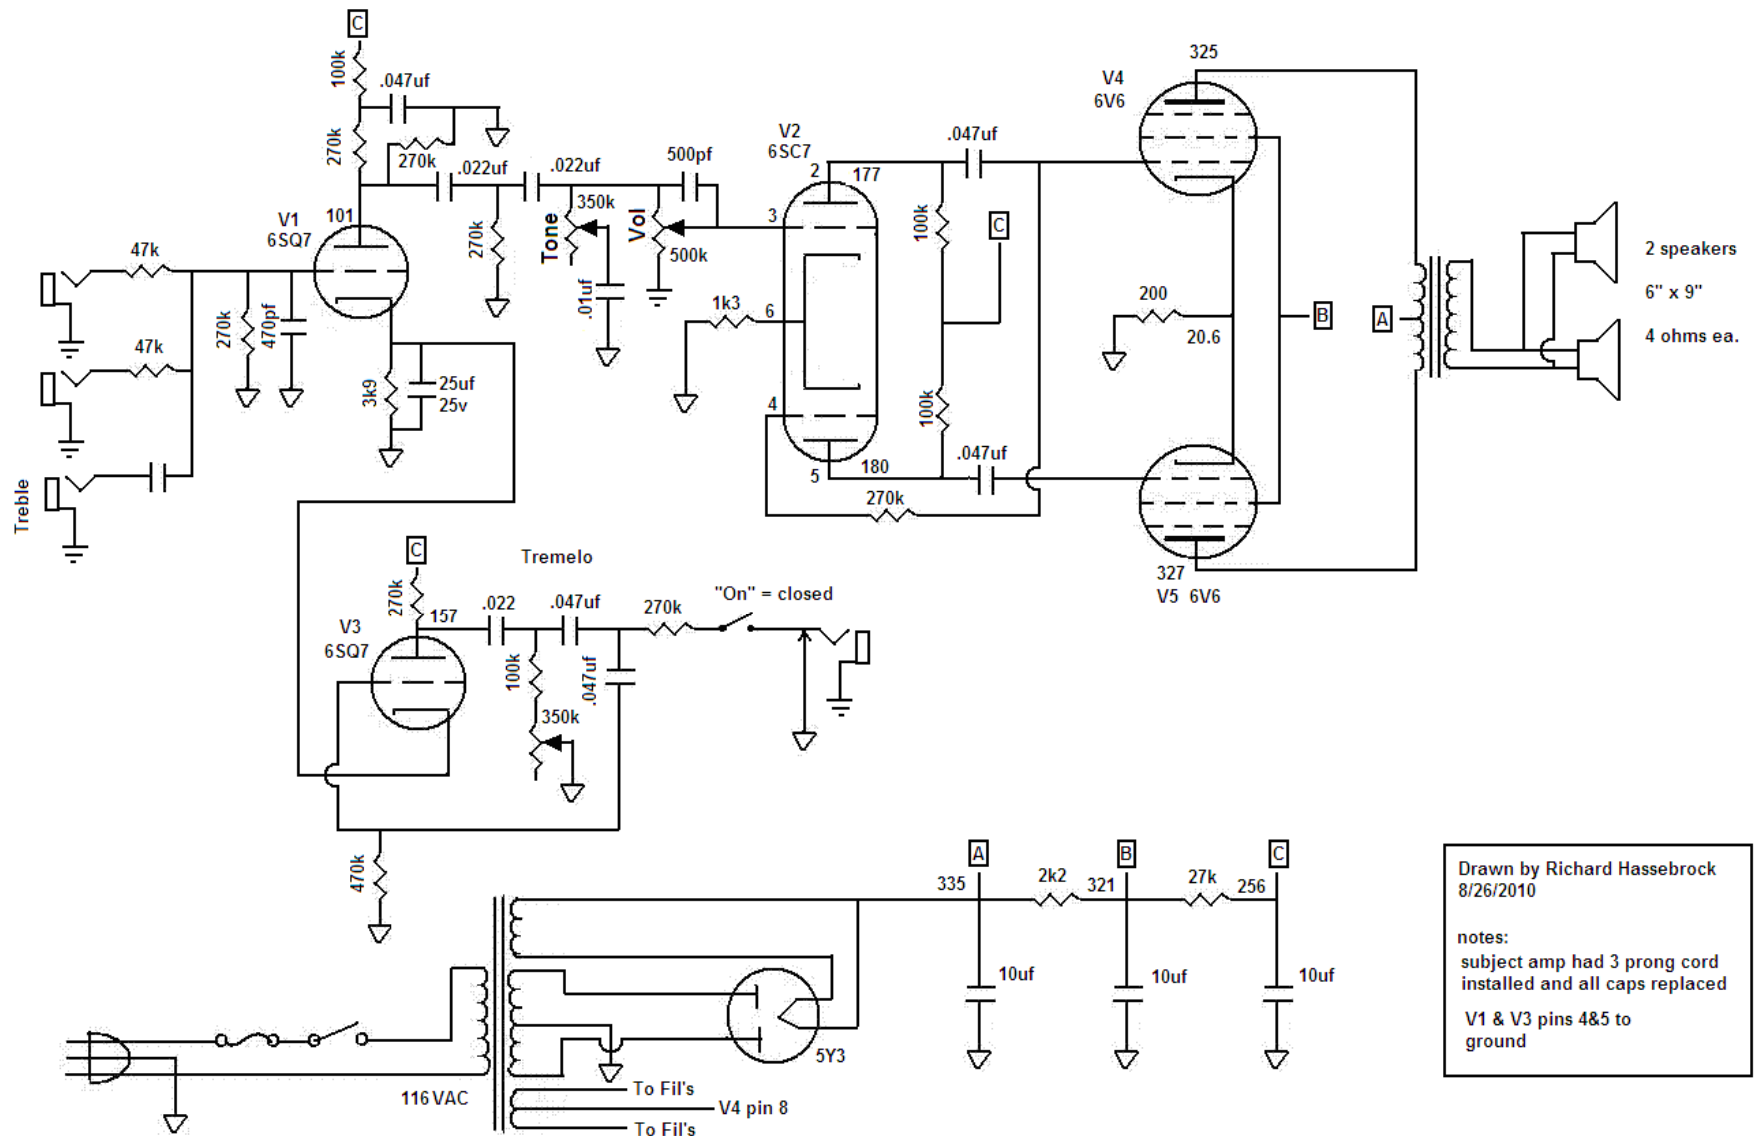
notes:
subject amp had 3 prong cord
installed and all caps replaced

V1 & V3 pins 4&5 to
ground
